TITLE: Proceedings of the U.S. Army Symposium on Gun Dynamics (7th)  
Held in Newport, Rhode Island on 11-13 May 1993.

**TITLE: An Analysis of the 120mm M829 Screening in Operation Desert Storm**

## AN ANALYSIS OF THE 120mm M829 SCREENING IN OPERATION DESERT STORM

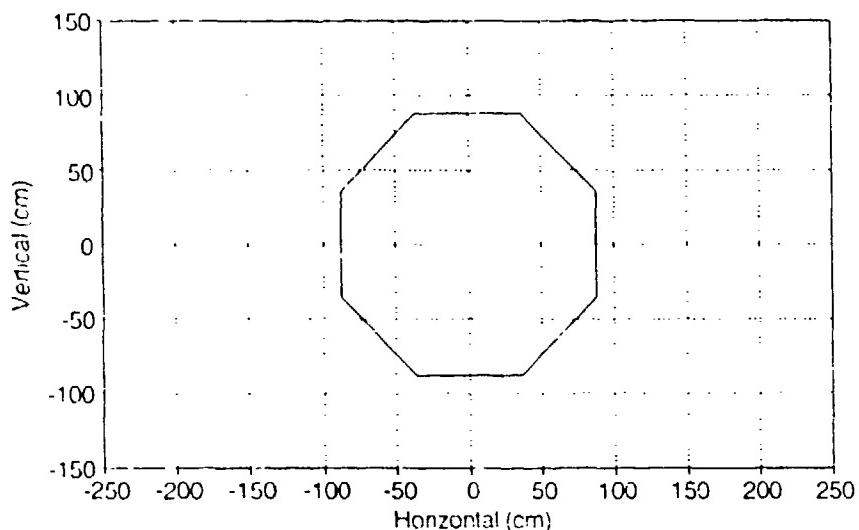
Figure 1. 120mm 1500 meter screening panel.

All the tanks in the battalion fired M829 at screening panels placed at 1500 meters. Figure 1 shows the 1500 meter screening panel. Initially, each tank was boresighted and applied the fleet CCF for the M829 round and attempted to fire for confirmation. Each hit was measured and the distance from the center of the panel to the hit was recorded. Figure 2 shows the mean point of impact (MPI) of the shots fired from the fleet CCF. Not shown on the figure are the locations of all the hits nor the 17 shots that missed the target short, one that missed to the right and three that flew over the target.

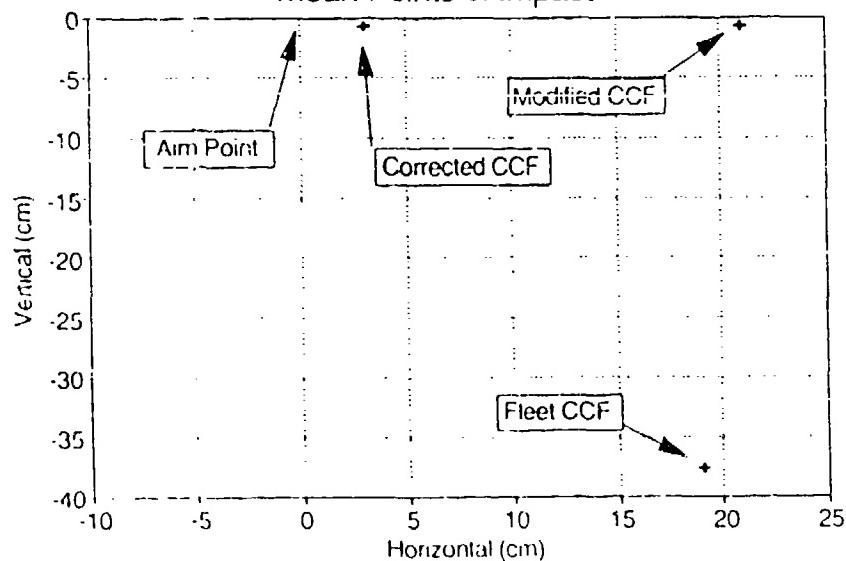
Figure 2. Mean Points of Impact.

At this point we decided to correct for the poor hit distribution observed in the M829 rounds brought from Germany. We computed a modified CCF for those tanks missing the panel or hitting low. Based on the distribution of hits the modified CCF was L0.13, U0.30. This is in comparison to the published CCF for the M829 of L0.13, U0.65. Figure 2 shows the MPI of those shots fired from tanks using the modified CCF. As a result of this correction, the MPI was brought closer to the aim point.

After a closer look at the strike of all the rounds a more precise computation of the MPI was computed. From these data a corrected CCF was found to be L~~0~~0.01, U0.34. This would be the CCF for these rounds fired for this screening occasion. Compared to our field estimate CCF of L~~0~~0.13, U0.30 we came close to the true mean point of impact for the vertical jump be since we ignored horizontal jump we were off roughly one tenth of a mil. Table 1 compares the fleet CCF with the modified CCF computed at the range and the corrected CCF computed in this report. The MPI based on the corrected CCF is also shown on figure two and the proximity of the MPI with the aim point is
